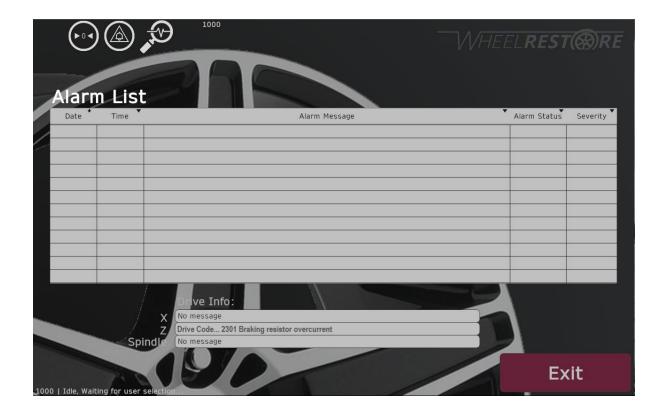
**Most likely Cause**: With the optional electronic brake activated, a heavy wheel has caused the motor to draw a higher current than it anticipated.

**How to resolve:** When completing the spin test at the beginning of the process, be sure to select the correct size of wheel from the 3 options. Selecting a small or medium wheel when repairing a wheel with a tyre fitted will cause this issue.

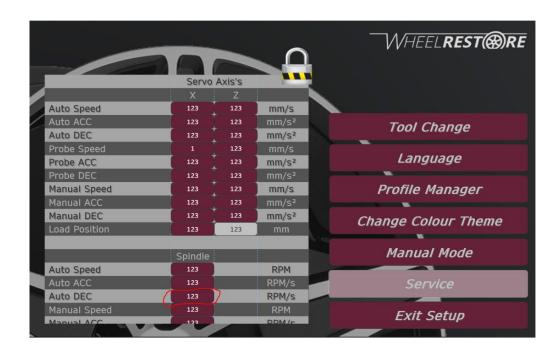
The alarm can also be triggered if a large wheel with a tyre fitted is too heavy for the deceleration speed. To rectify this, change the deceleration speed on the settings to a lower value so the spindle brakes at a slightly slower speed. The setting to change is circled in red in the image below.
